HOW TO CHANGE THE INNER CV BOOT/DRIVE SHAFT

This guide illustrates how to remove and replace the drive shafts and CV boots. The image below shows the passengers side drive shaft with CV boots in good condition. Over time the boots perish and split and the centrifugal force spits the grease all over the place. A burning smell coming through the air ducting is a good indicator that this has happened.

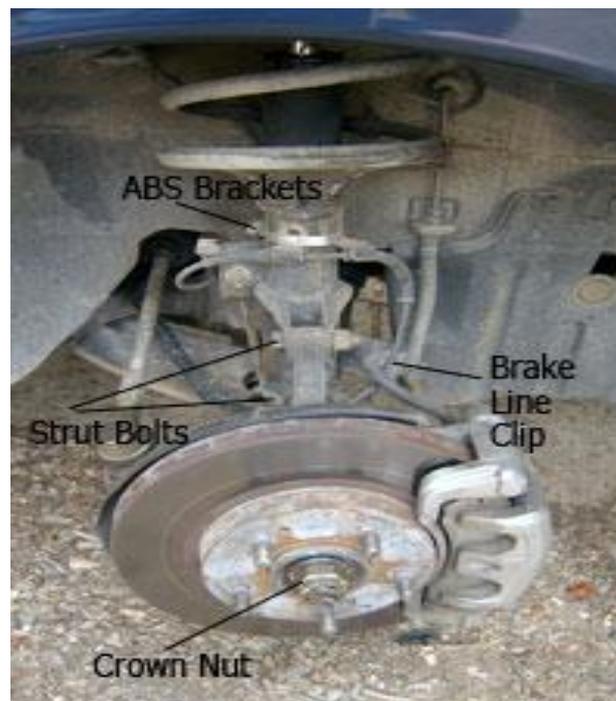
Step 3. Remove the wheel. You should now be faced with a picture similar to that below.

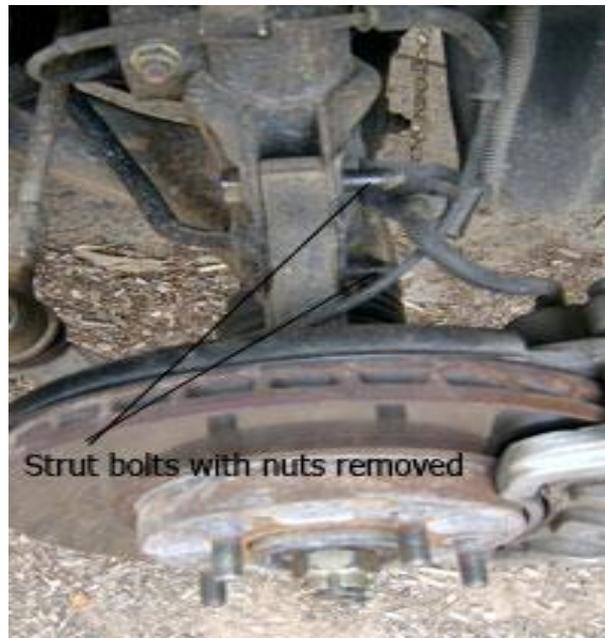
Step 6. Remove the nuts off the 2 strut bolts. Having done this, your car should look similar to the picture below.

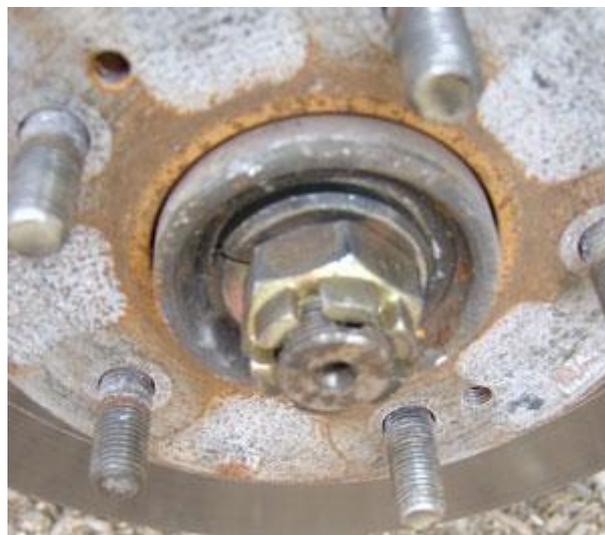
Step 7. Remove the split pin from the crown nut. Once the pin is removed, it should appear as below.

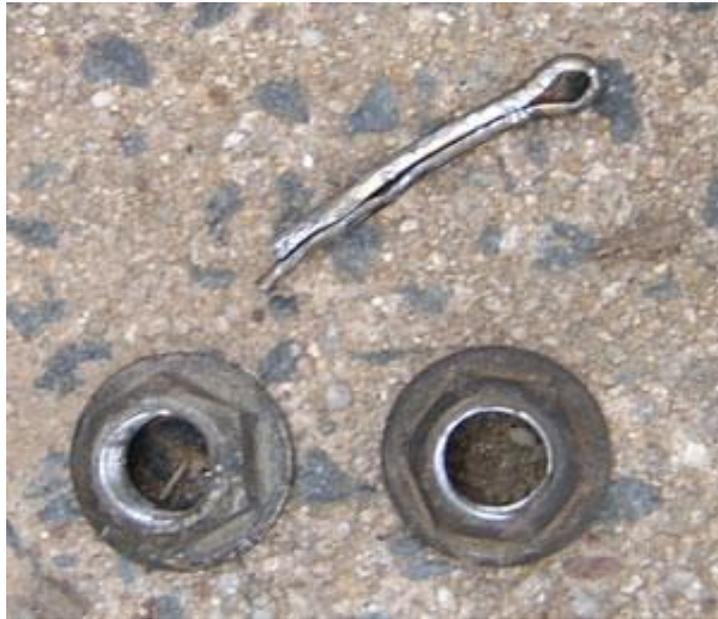
The split pin and strut nuts are pictured below:

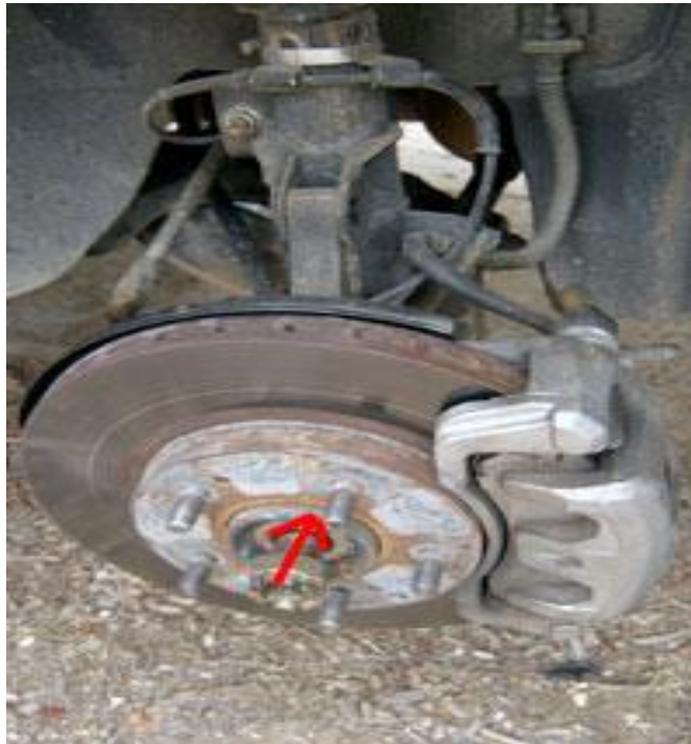
Step 8. Loosen the crown bolt. If you have a rattle gun, this bit is fairly easy. If not, get someone to put their foot on the brake while you attack the nut with a socket. Once you have loosened it, wind it off most of the way (as pictured below).

Step 9. Give the nut a tap with a hammer. The shaft should move in the direction of the arrow.

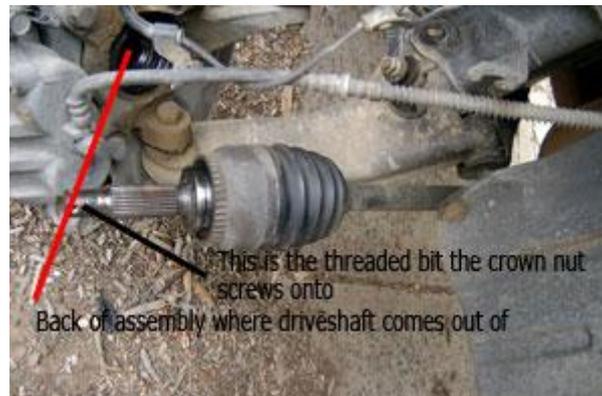
Step 10. Pull out the strut bolts and let the disc assembly fall towards you. Pull the driveshaft out of the back of the assembly.

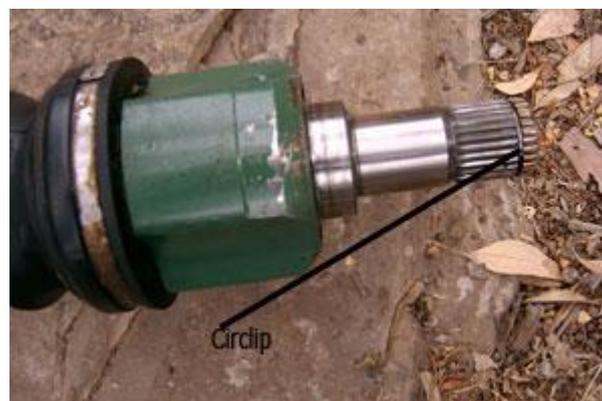
The inner side of the drive shaft is secured by a circlip (as shown below). This has to be compressed so that it can be removed.

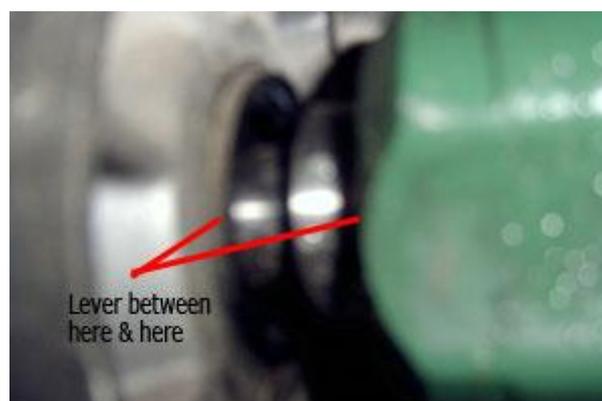
Step 11. Place your bucket under the location where the inner shaft meets the gearbox (as shown below)

This is a little hard to see and the picture isnt great Look for the green bit.

Step 12. With one person under the car with a screw driver and another levering from the wheel well area, apply enough leverage to the circlip to remove the drive shaft. The picture above shows a driveshaft that has already been sprung. You will need to lever between the 2 points shown.

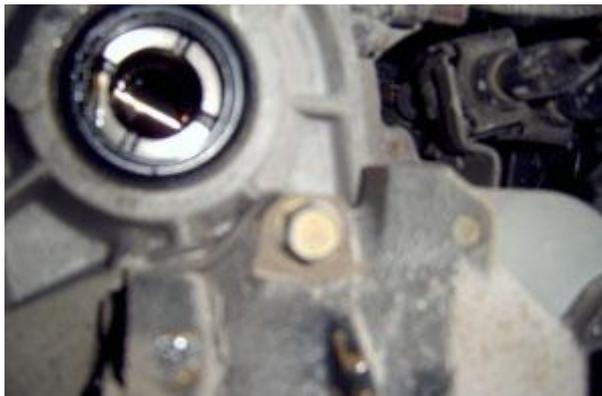
This process is much easier with a hoist. Try and keep the shaft level and with a bit of fiddling it will pop out. Be aware that the moment this happens, the transmission fluid will start to drain out of the hole shown below.

This is a picture of a manual transmission. The tip looks similar though.

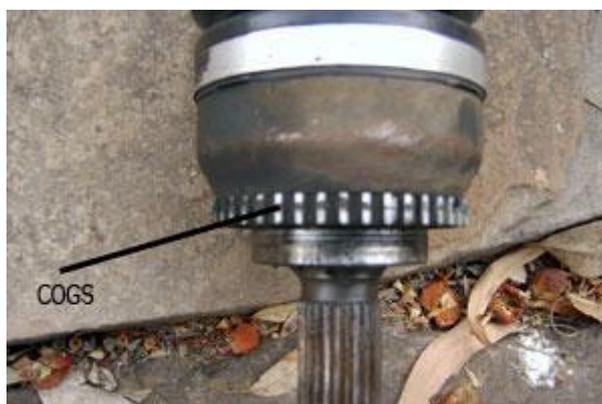
At this stage the shaft can be removed. An ABS shaft will have the cogs as shown below. A non ABS shaft will not have these.
